April 30, 2003

**RE: Long-Term Operations and Maintenance Annual Report (Soil Remedy)
South Cavalcade Superfund Site – Concrete Cap**

This letter and attachments serve as the 2002 Long-Term Operations and Maintenance Annual Report (Report) for the soil remedy of the South Cavalcade Site located in Houston, Texas. This report is submitted to the Environmental Protection Agency as required by the Remedial Action Work Plan for the South Cavalcade Site on behalf of Beazer East, Inc.

Project Name/ Client:
South Cavalcade Long-Term O&M
Annual Report

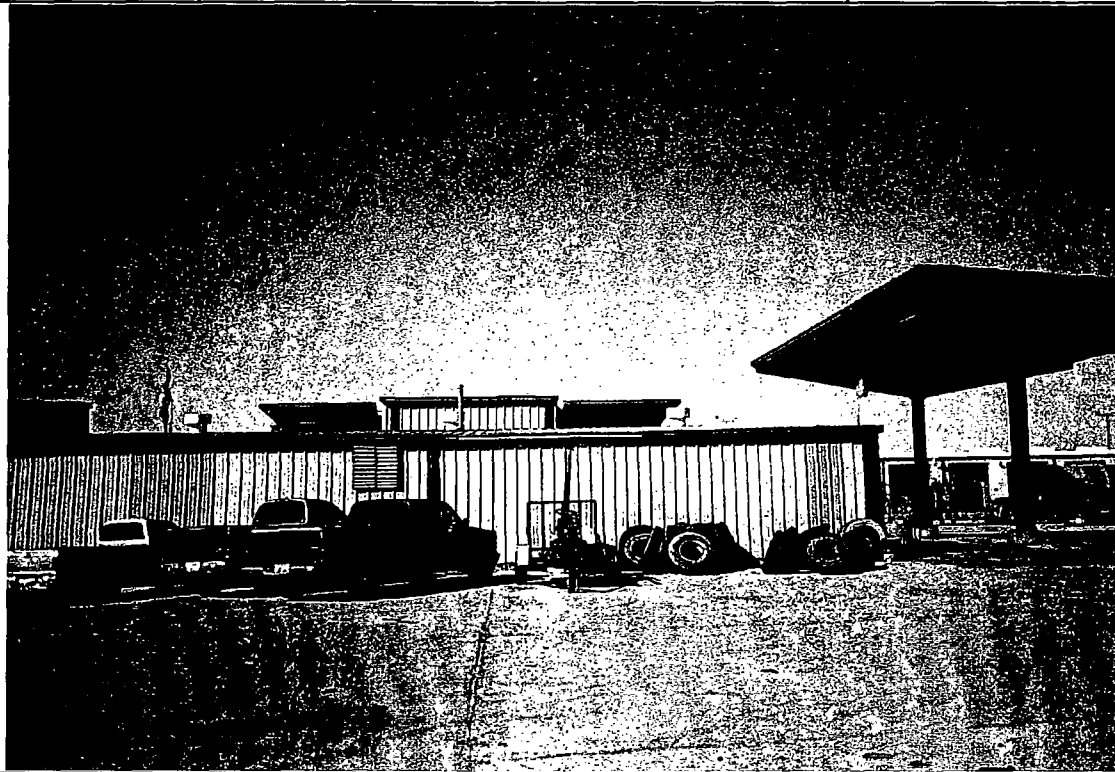
Photo No.
1

Photo shows on-site tire shop and typical condition of cap pavement and joint system. In basin 4 of the southeast area at the approximate location of cap and pavement.

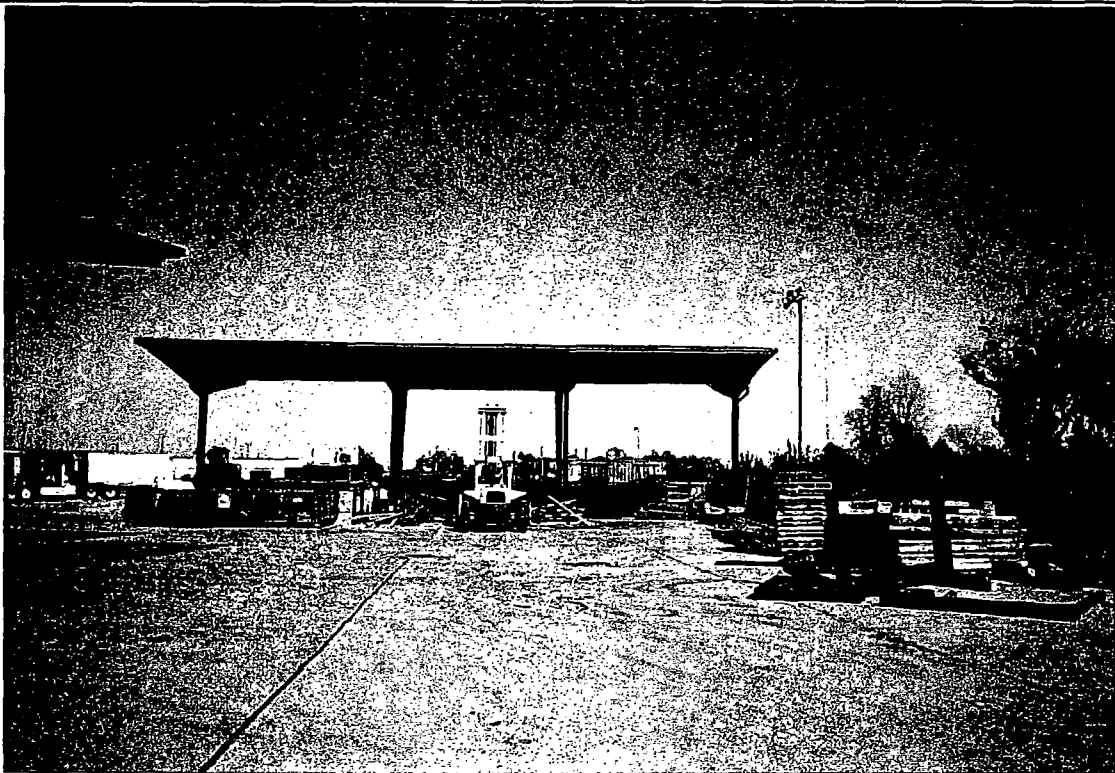
Photo No.
2

Photo shows basin 4 of southeast area concrete and joints.

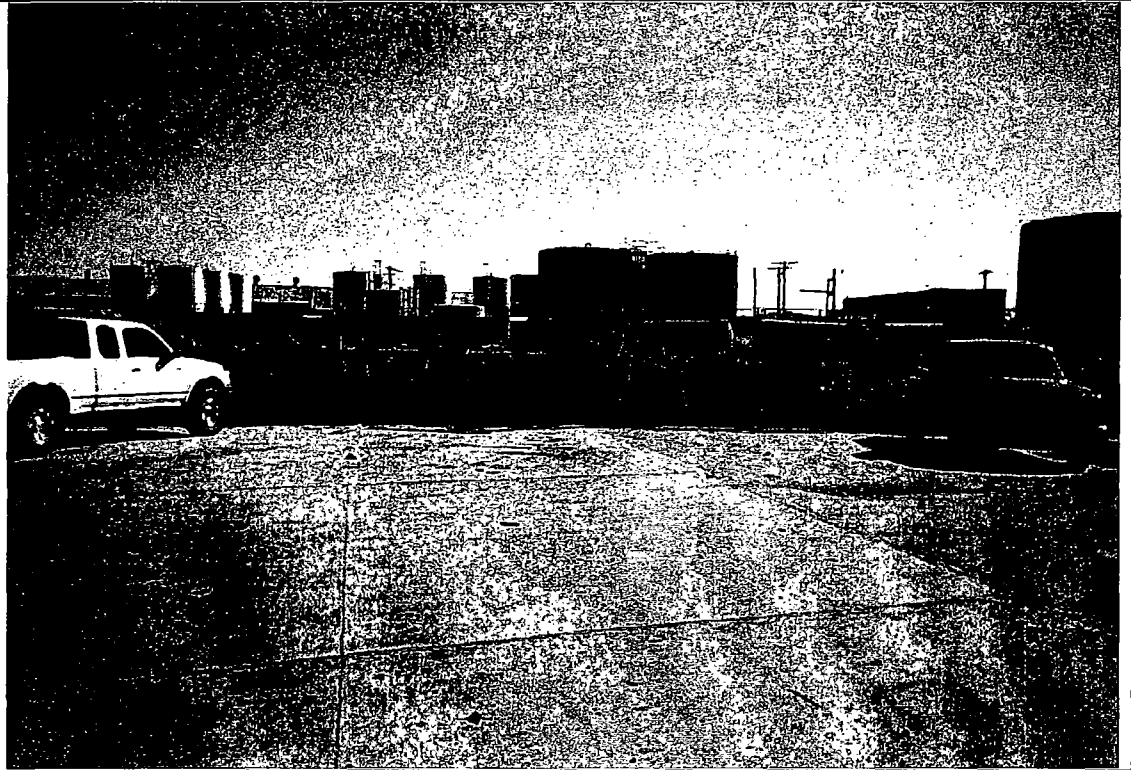
Photo No.
3

Basin 4 concrete cap and
joint. Photo also shows
typical use of cap in
southeast area.

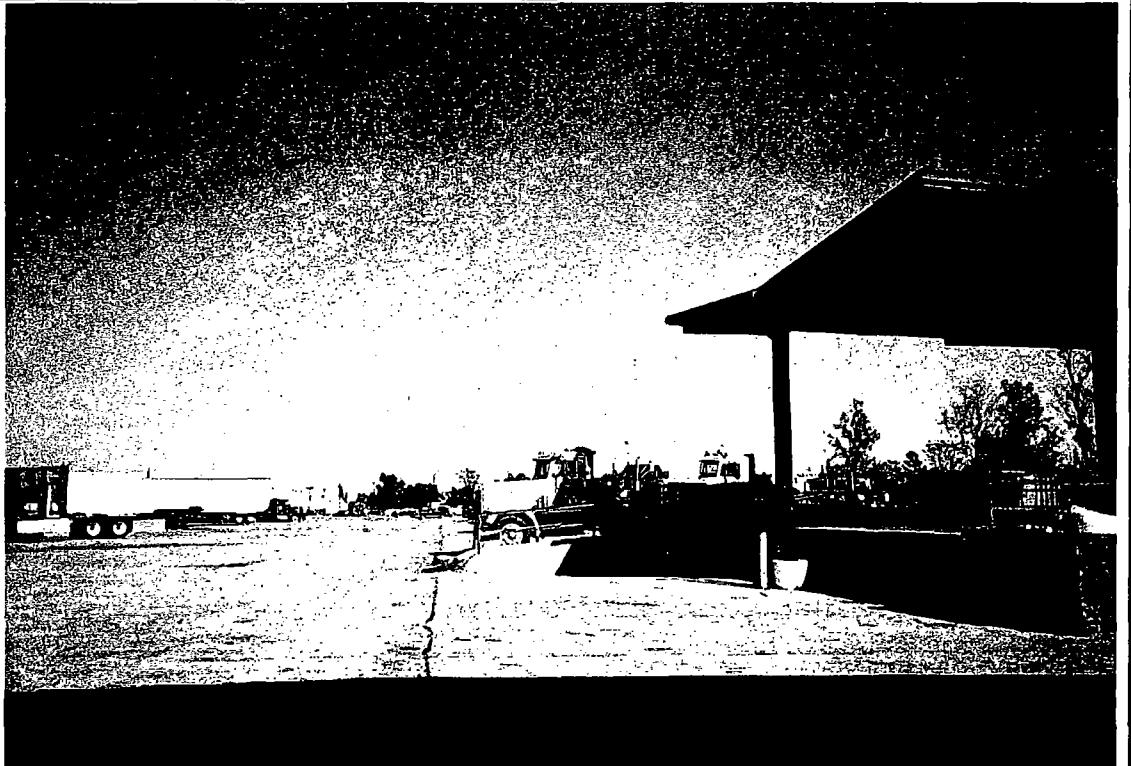
Photo No.
4

From basin 4 in southeast
area along existing
pavement and concrete
cap edge at ramp.

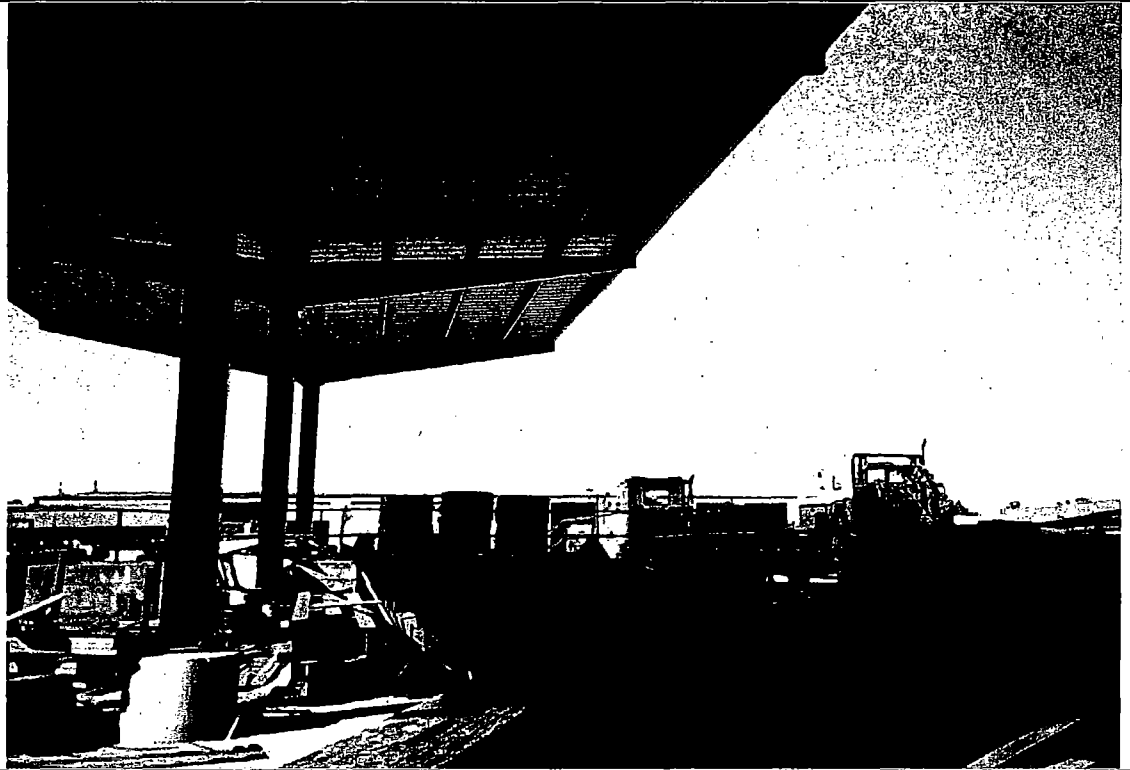
Photo No.
5

At basin 4 and 3 interface
along eastern property
line in southeast area.
Cap area shown is being
used for storage.

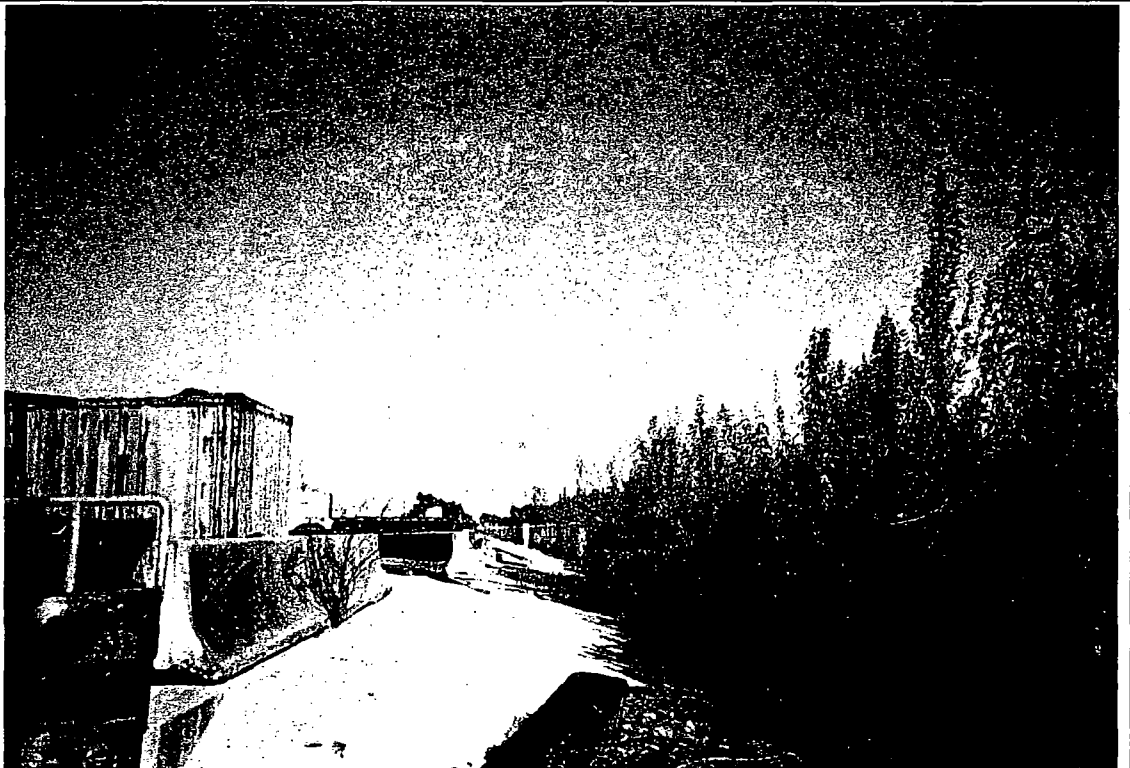
Photo No.
6

At basin 3 in southeast
area along slope
pavement near property
line. Concrete is in good
condition.

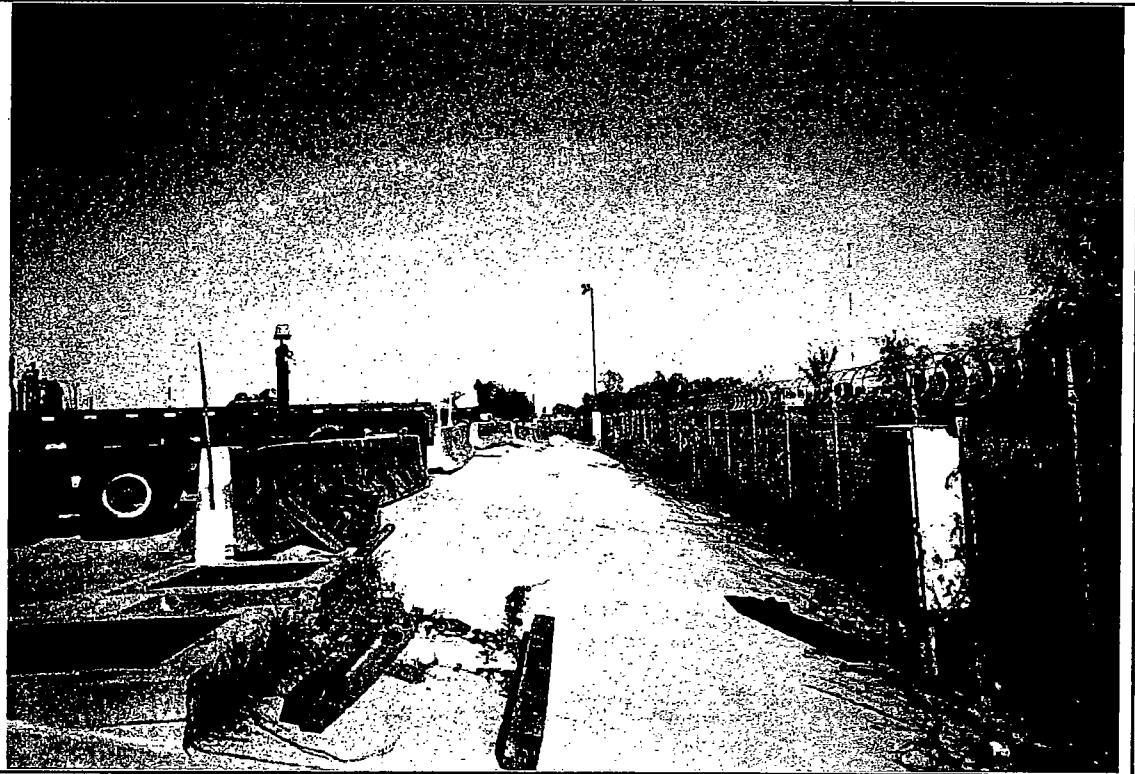
Photo No.
7

Photo taken along slope
pavement in southeast
area at the existing utility
box location.

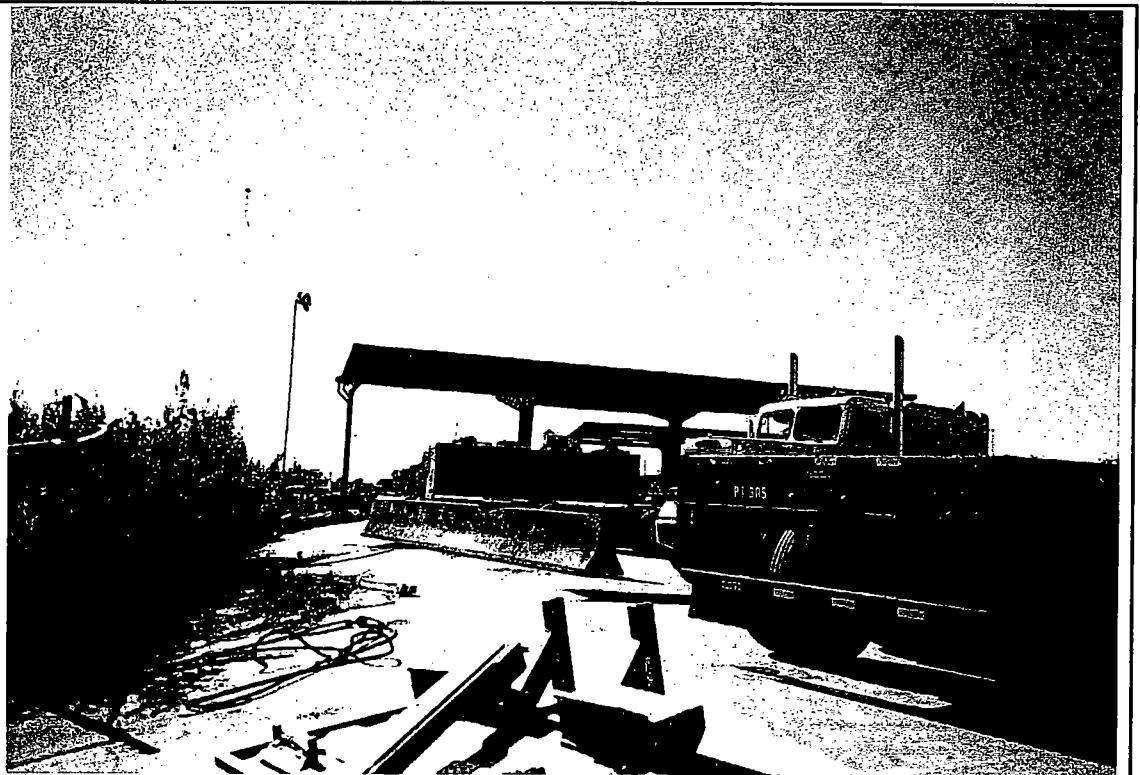
Photo No.
8

From basin 3 in southeast
area along property line.
Photo shows slope
paving.

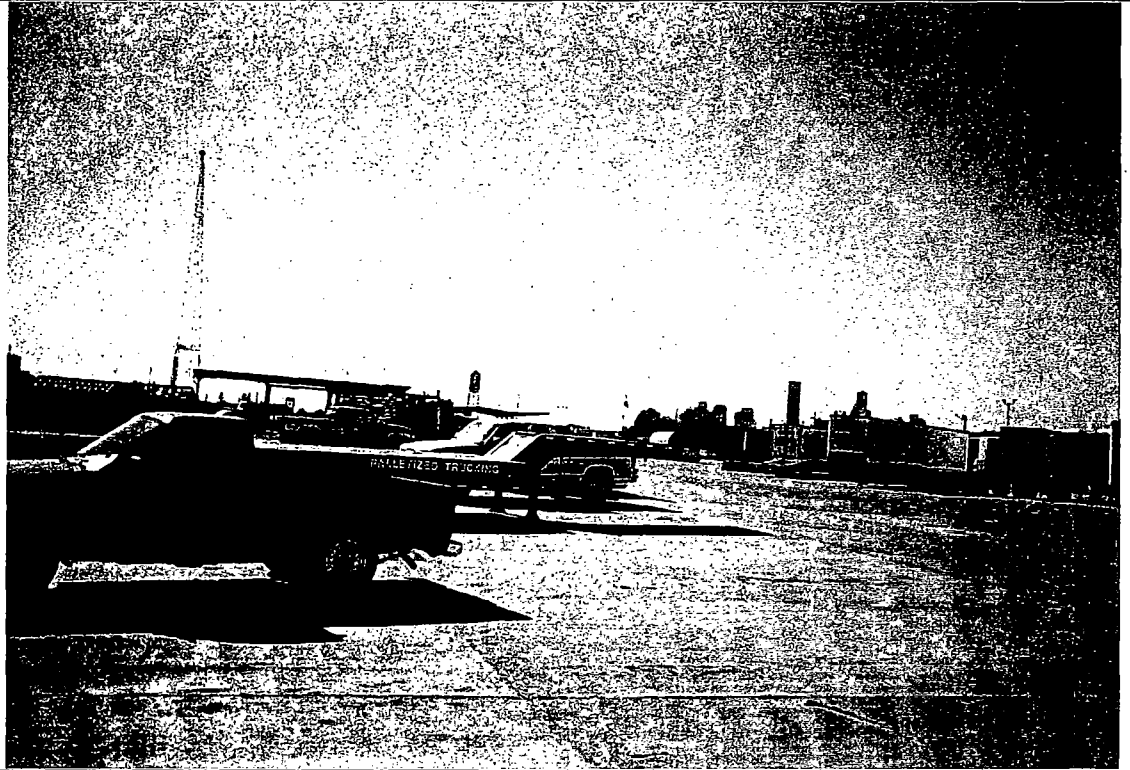
Photo No.
9

From basin 1 towards
basin 2 in southeast area
along the edge of existing
pavement and concrete
cap.

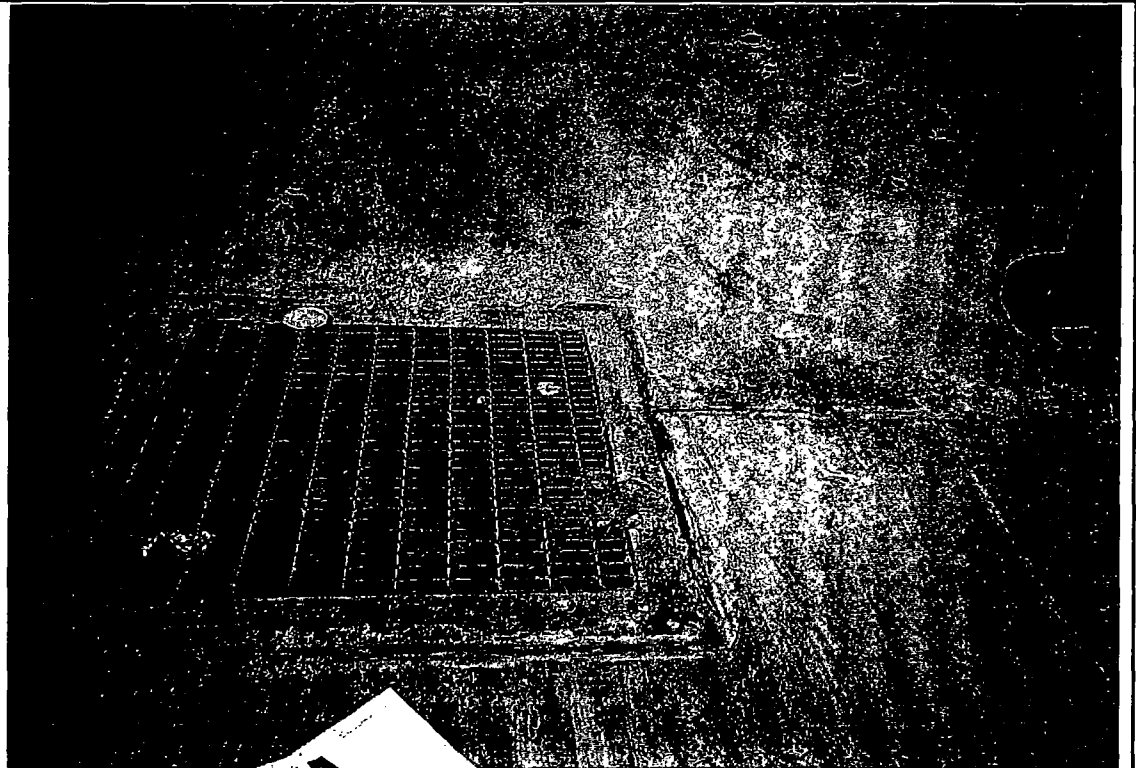
Photo No.
11

Photo shows typical
condition of stormwater
inlets and concrete joint
material surrounding
inlets.

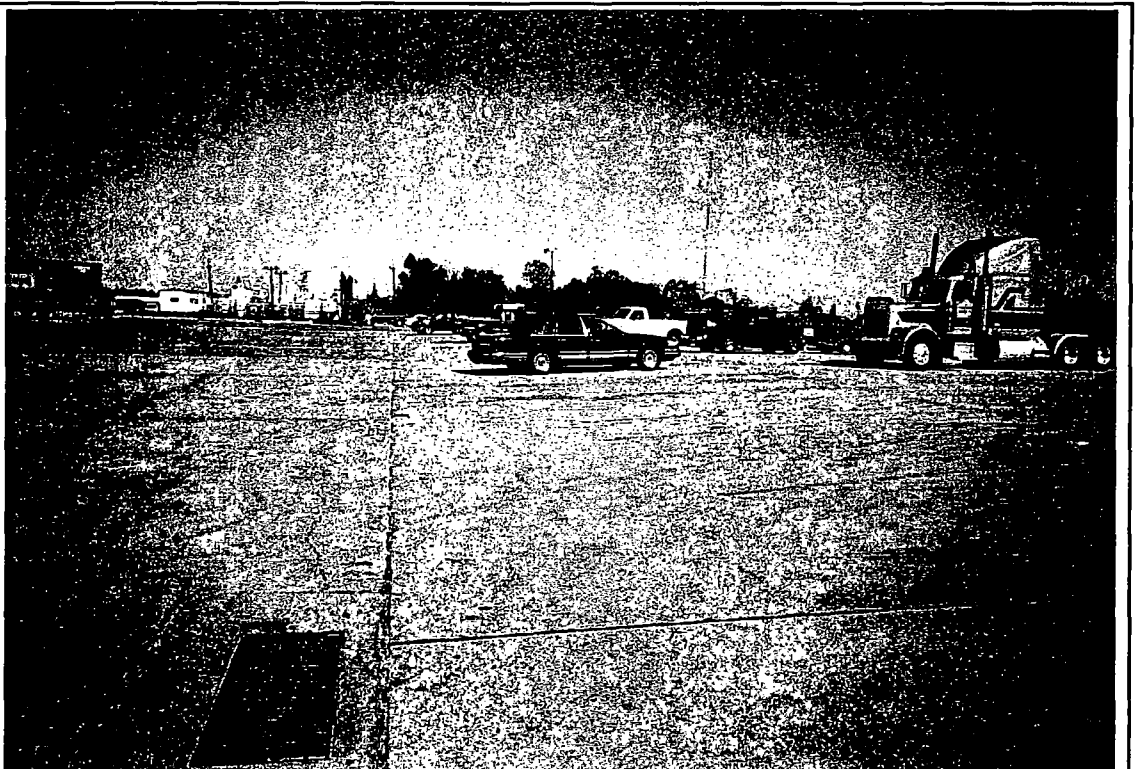
Photo No.
12

From basin 2 towards
basin 1. In southeast area.
Photo shows stormwater
inlet and condition of
concrete cap (to the right).
Joint system appears to
be good repair.

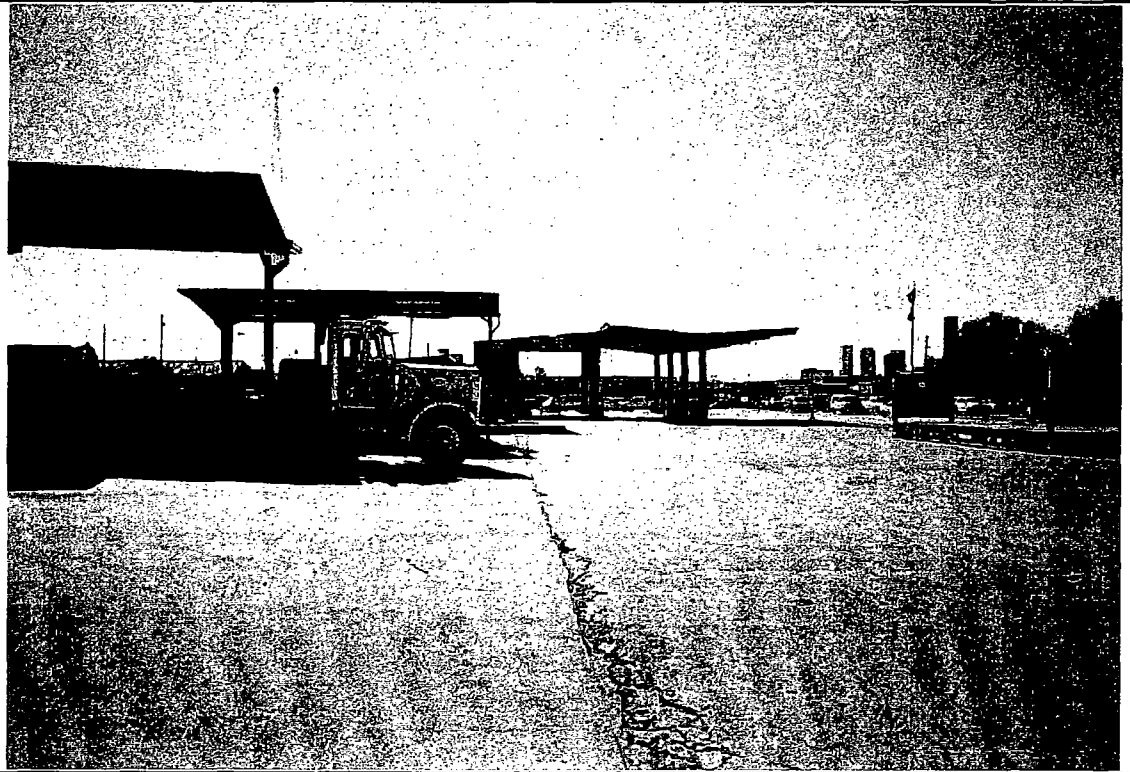
Photo No.
13

From basin 3 towards
basin 4 in southeast area.
Photo shows concrete cap
and joint.

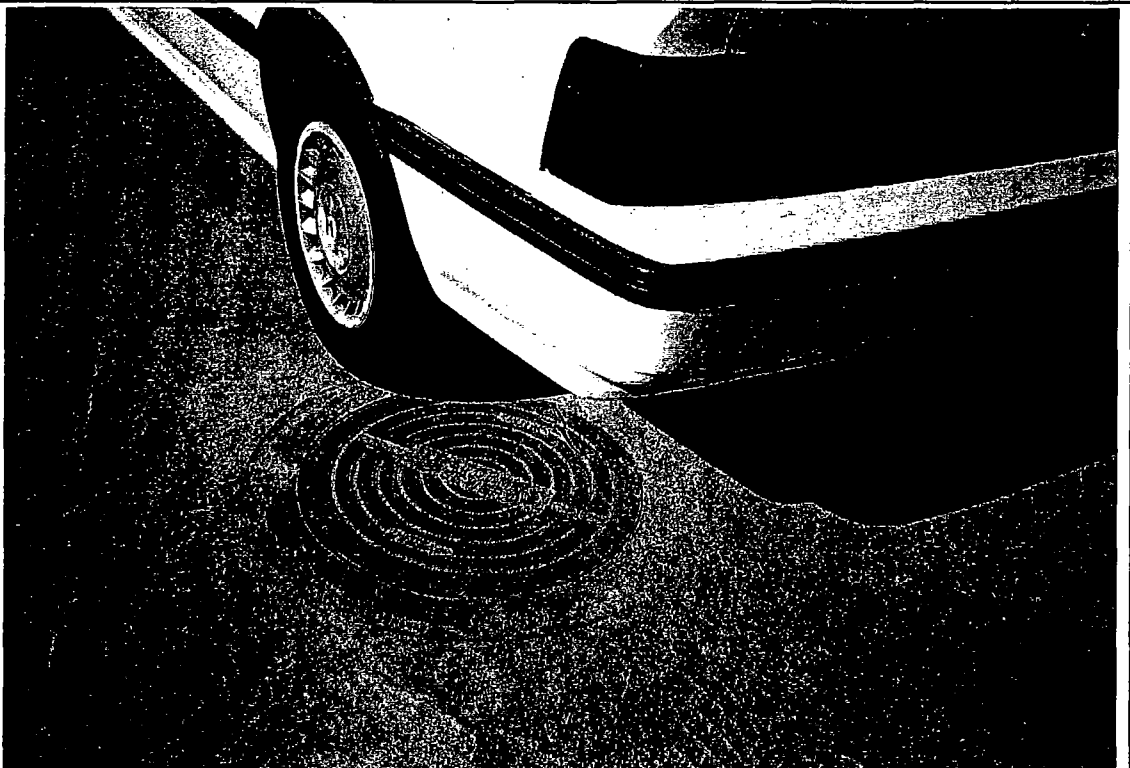
Photo No.
14

Photo shows typical
condition of manholes in
southeast area.

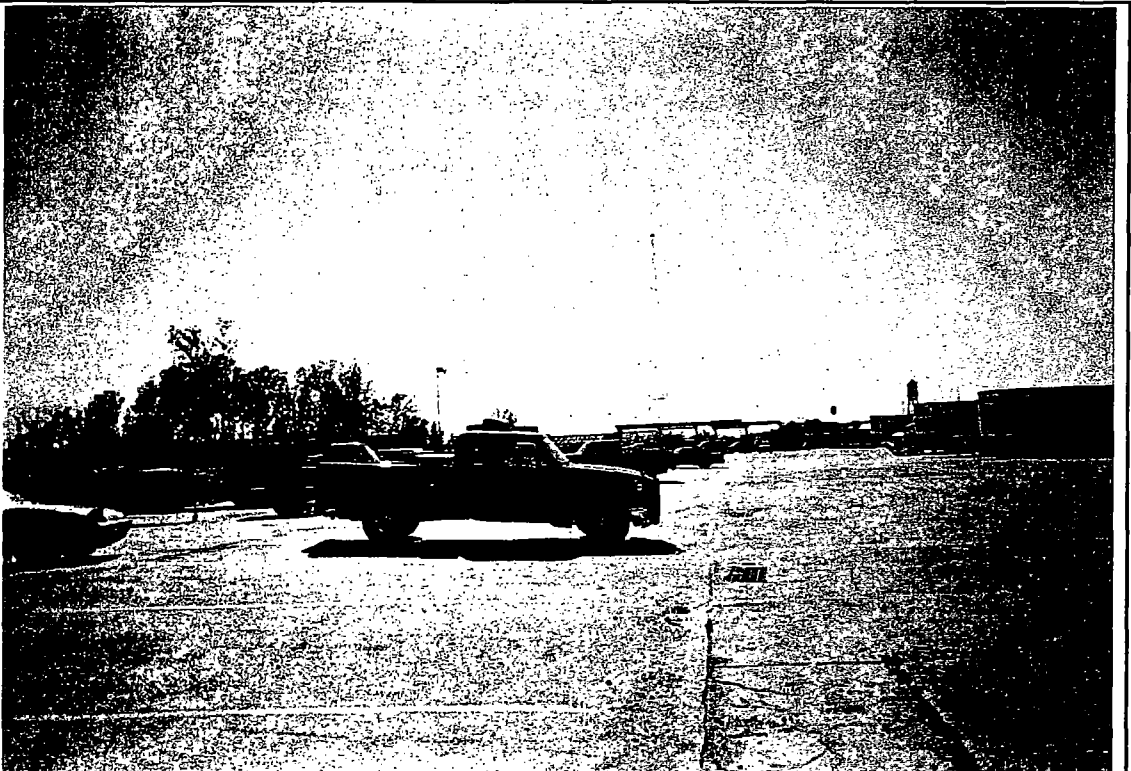
Photo No.
16

Photo taken along existing
pavement edge with
concrete cap. Typical use
of cap in southeast area
for parking is shown.

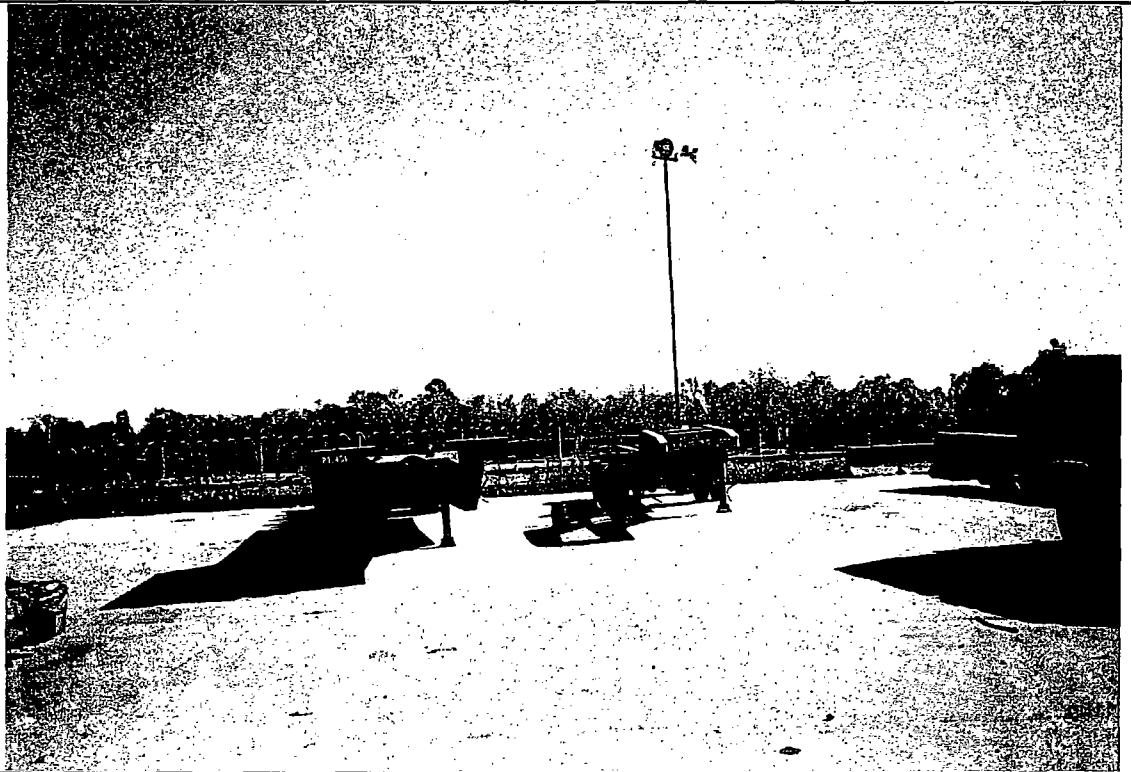
Photo No.
17

Similar to photo 16.
Shows concrete cap in
southeast area. Photo is
taken from the northern
end of basin 1.

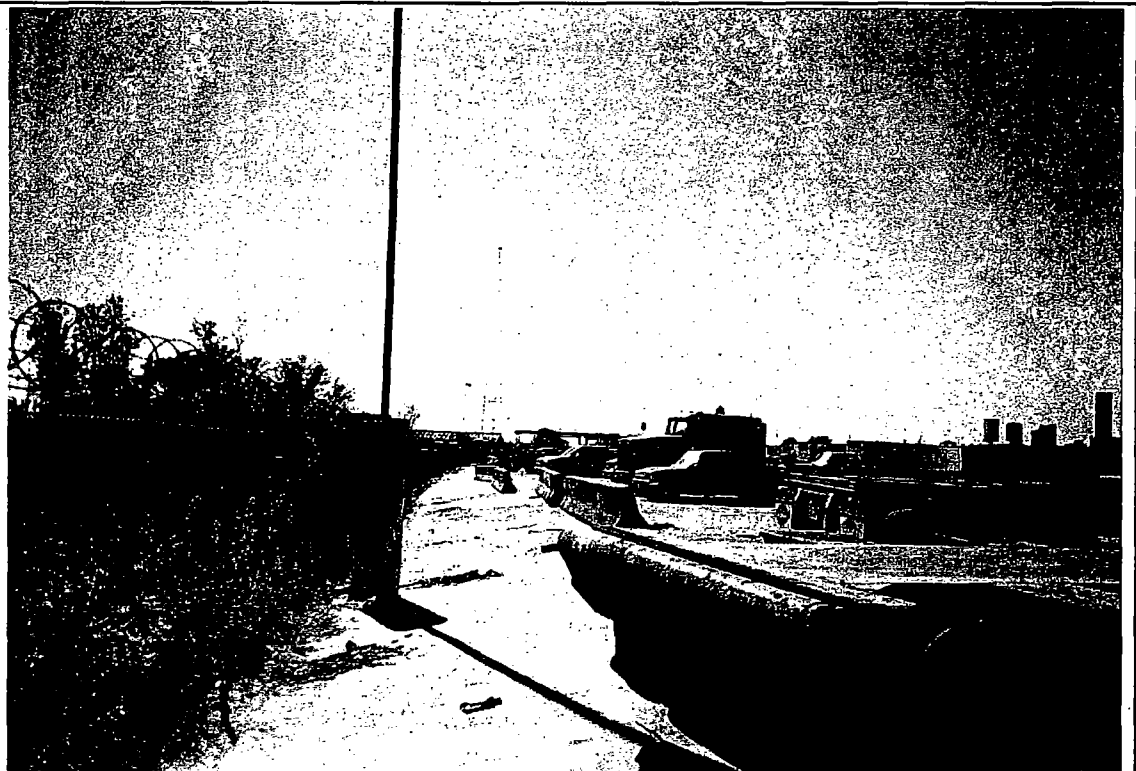
Photo No.
18

Photo shows slope
pavement that connects to
concrete cap at the
northern end of concrete
cap in the southeast area.

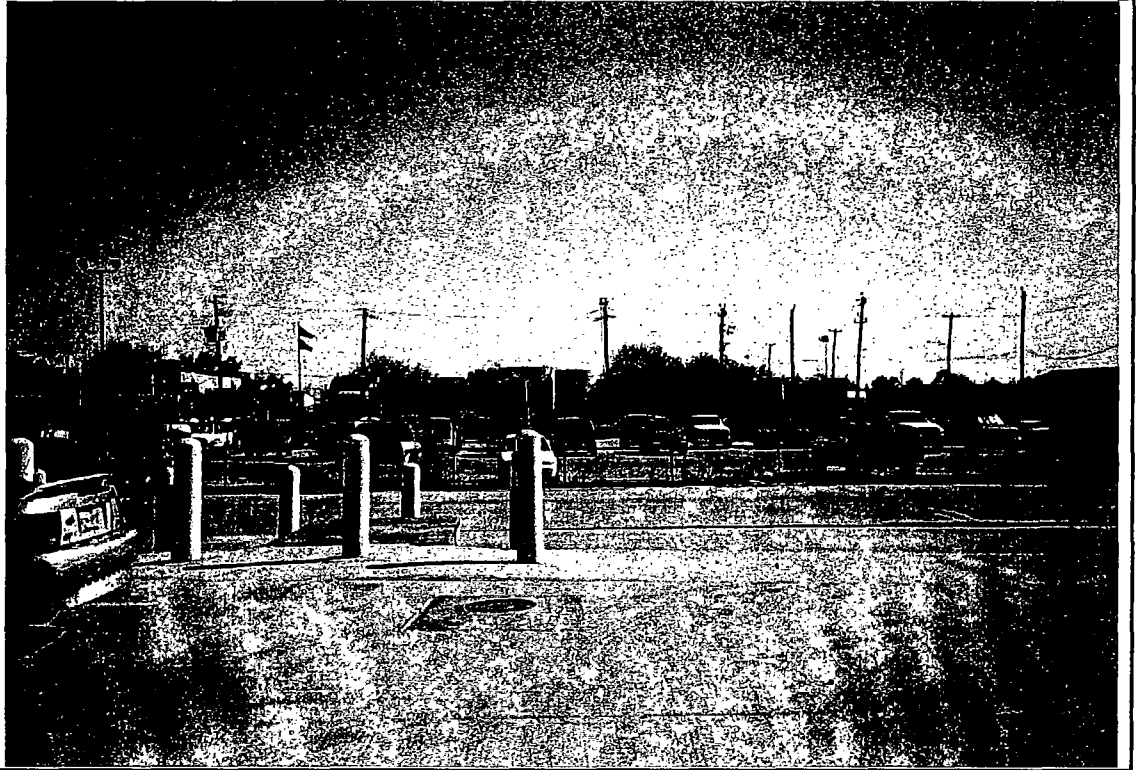
Photo No.
19

Photo taken on the concrete cap in the southwest area. Photo shows protective bollards in the northeast corner of cap.

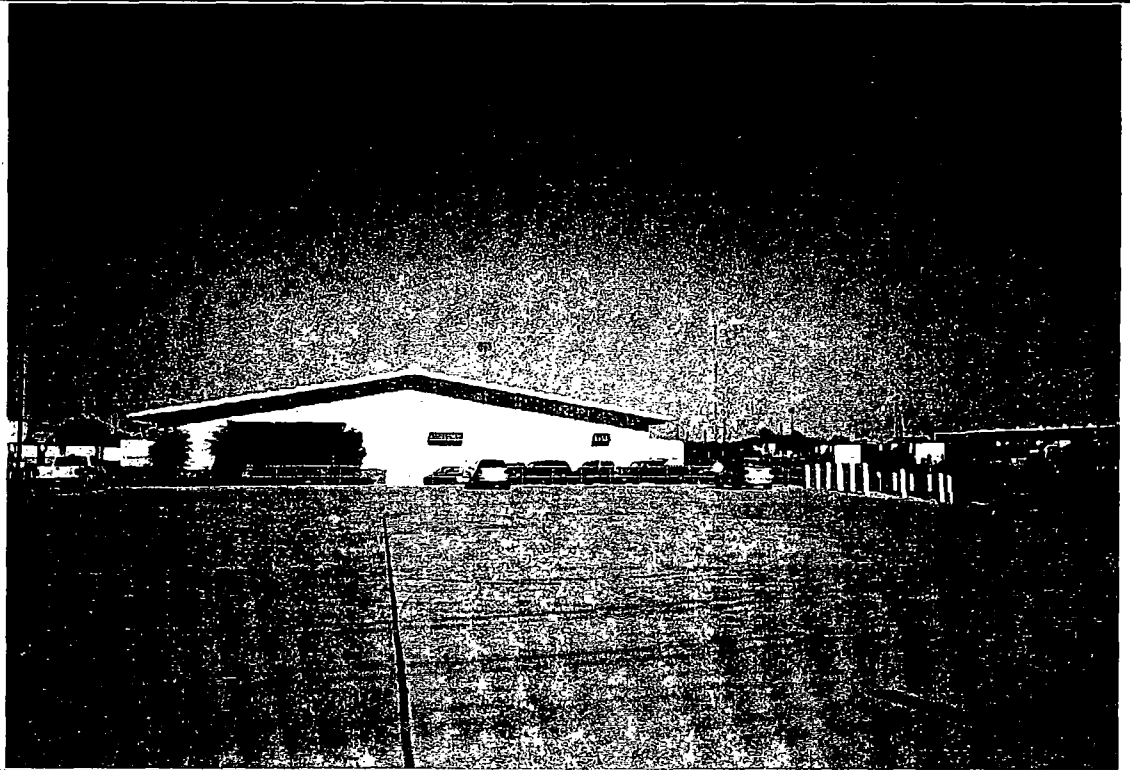
Photo No.
21

Photo taken along the
southern edge of concrete
cap in the southwest area.
Joint is in good condition.

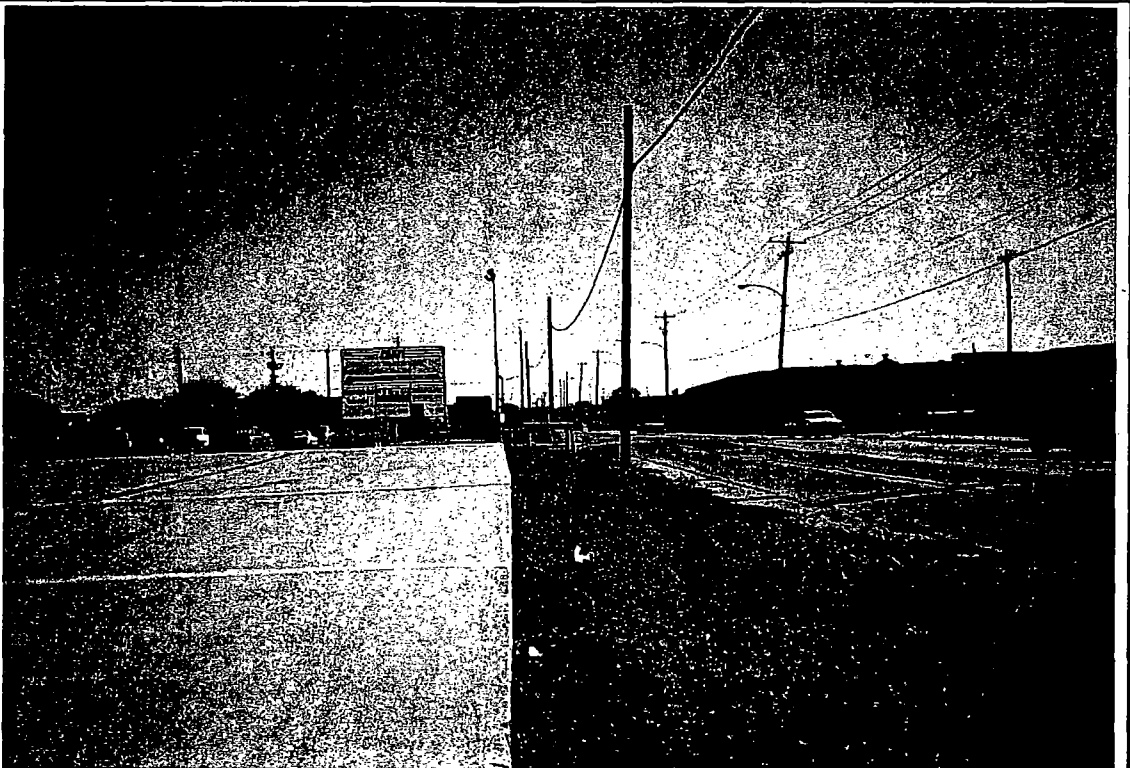
Photo No.
22

Photo taken along the
southern edge of concrete
cap in the southwest area.
